Hillside Elementary School

Civil Assessment

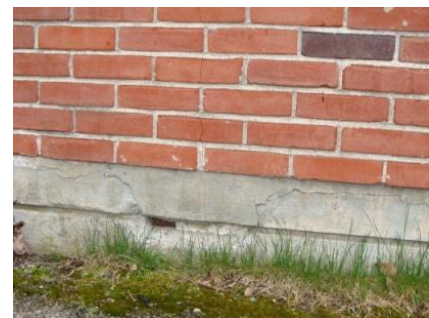
Image 4

Building foundations under the original building are uninsulated, cast-in-place concrete and lose substantial heat to the ground. The requirement for a vapor barrier under concrete slabs was not introduced into model codes until much later so it is likely that moisture is moving freely between the ground and interior. Limited concrete spalling is occurring in places on the 1968 addition and some steel embedments can be seen exposed to the outside (see Image 4).

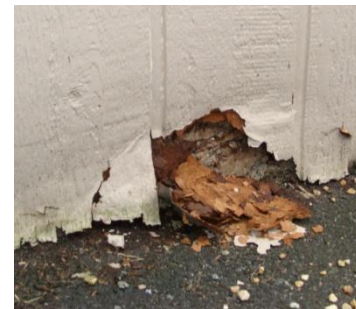
Image 7

The modular building exterior walls are finished with a composite paper sheathing painted gray. The sheathing is severely water damaged in several places where it comes in contact with ground water (see Image 7).

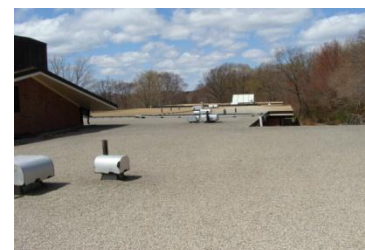
Image 18

The main part of school has had a new roof (image 18) put on in 2003 consisting of gravel surfaced built up roof system set in hot asphalt, with insulation levels varying from 1-3". The modular buildings have a single ply membrane roof (Image 24) with 1-3" of insulation. The entire roof would require approximately 3" of additional insulation to meet current energy code. Built up roofs of this type usually last approximately 15 to 20 years before a re-roof is required. The Roof overhang on the west side of the 1968 building has areas of significant concrete spalling and exposed rebar (see Image-19).

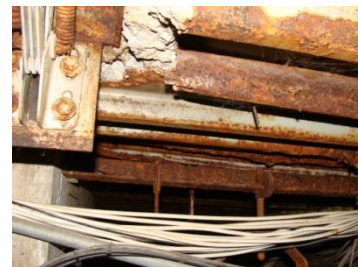
The condition of the first floor structure is of concern due to continued flooding and moisture in the tunnel area, see Image 20 which shows the rusting of structural steel members located in the tunnel.

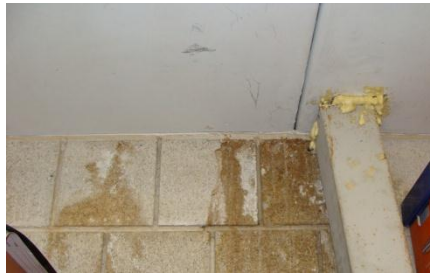
Image 24

Ceiling in the original 1959 portion of the building are perforated metal panels with flush mounted fluorescent lights. The 1968 addition has precast concrete plank ceilings (Image 24) and some ACT tile as well.

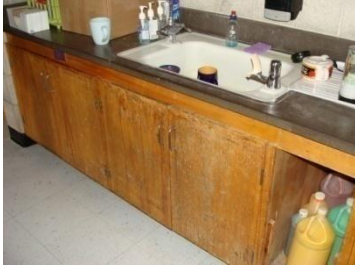
Image-25

Existing cabinets are generally in good to fair to good condition (see Image 25). Lockers are generally in good condition and fit for continued use. There is a lack of handicapped accessible lockers.

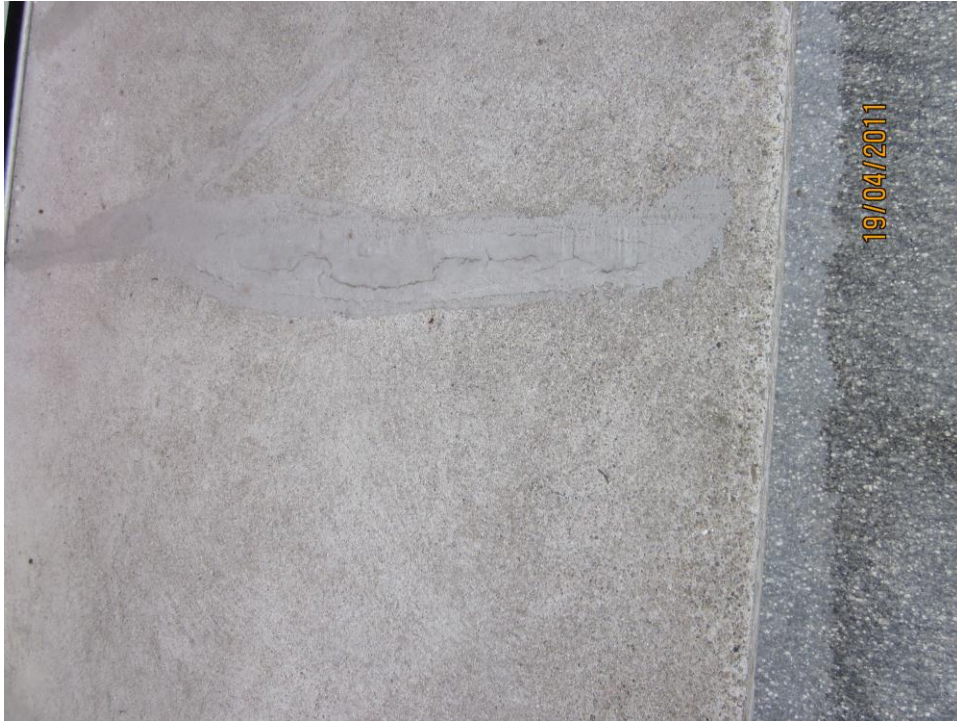
There are no obvious signs of any settlement or distress to the foundations other than some localized cracking at the cantilevered slabs on grade at the exterior (Refer to Photos 1 – 2). The exterior exposed steel shows no signs of corrosion and internally the exposed structure both floors and roof substrate are in sound condition.

In our opinion, the structures for both original building and addition are in sound condition other than some minor shrinkage cracking at exterior slabs

Photo 1: localized cracking at exterior cantilevered slabs on grade.

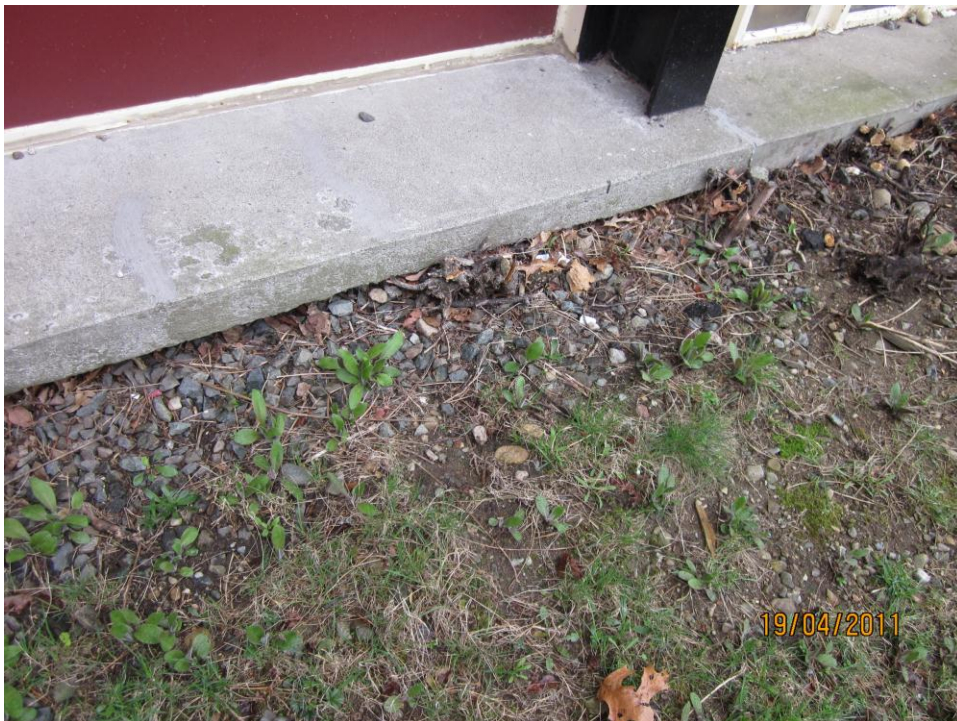
Photo 2: localized cracking at exterior cantilevered slabs on grade.

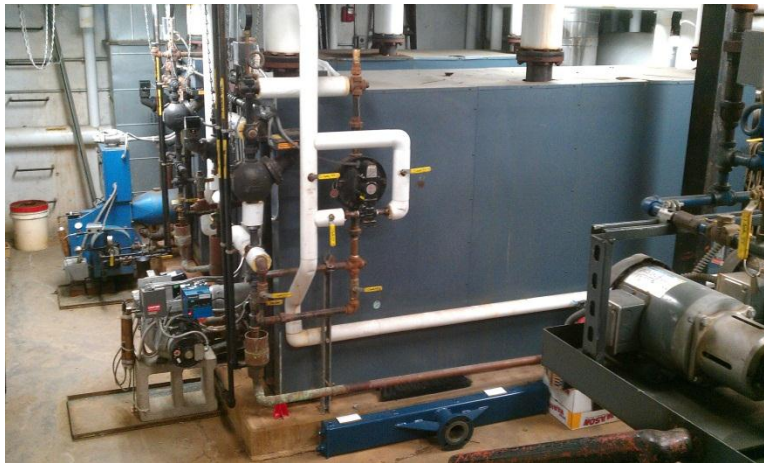
1. **Main Steam Boilers:** The existing building HVAC system consists of two, cast iron, sectional type, Weil McLain low pressure steam boilers. The boilers appear to be from a 1998 renovation. Both boilers burn #2 fuel oil. Total heating capacity of both boilers amounts to approximately 7,100 lbs/h of steam or 6,700 MBH.

Existing Boilers From 1998 Boiler Room Renovation

1. Condition:
 - a. Main Steam Boilers: The two boilers are both in good condition. Both appear to have been installed in 1998 during the boiler room renovation and can be expected to last another 10 years.
 - b. Fuel Oil System: Fuel oil piping and pumps appear to be in good condition. The underground storage tank is likely original, and has never been tested. The underground storage tank is expected to be in poor condition.
 - c. Cooling: The existing window air conditioners present were in varying conditions ranging from good to poor. An estimated 50% of all window air conditioners are in poor condition.

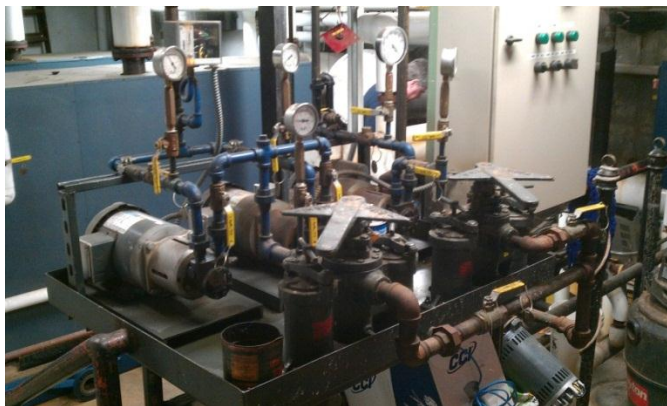
2. **Fuel Oil System:** The existing boilers are fed fuel oil from a 6,500 gallon underground oil storage tank which reportedly is the original tank from 1958. Fuel oil enters the boiler room and is distributed to each boiler via three fuel oil pumps. There is no tank monitoring system in place and the underground storage tank has never been tested.

Fuel Oil Pumps

- b. Fuel Oil System: The capacity of the fuel oil system appears to be adequate. Because of the condition, the entire fuel oil system needs to be replaced. Conversion to natural gas fuel should be seriously considered if services become available.

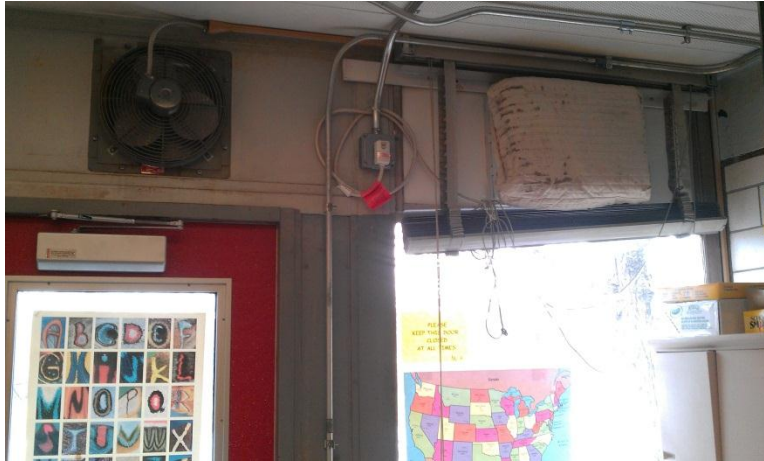
3. Cooling: There is no main cooling system in place. Cooling is provided by the occasional window air conditioner.

Window Air Conditioning Unit & Wall Exhauster

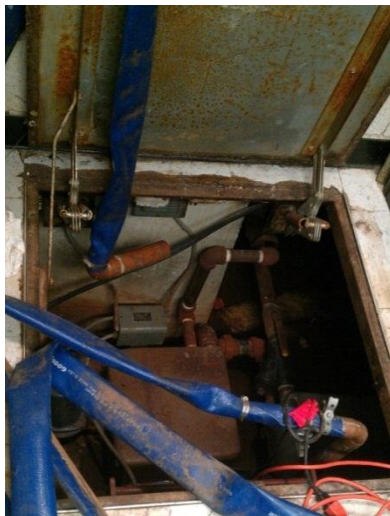
*View Into The Underground Trench
Where Steam Piping Runs*

- e. Finned Tube Radiators: Finned tube radiators range from fair to poor condition with an estimated 75% being in need of replacement.
 - f. Piping: Piping within the boiler room was reinsulated during the boiler room renovation project in 1998 and is generally in good condition. Piping outside the boiler room runs through underground trenches, is prone to annual flooding, and is expected to be in poor condition.

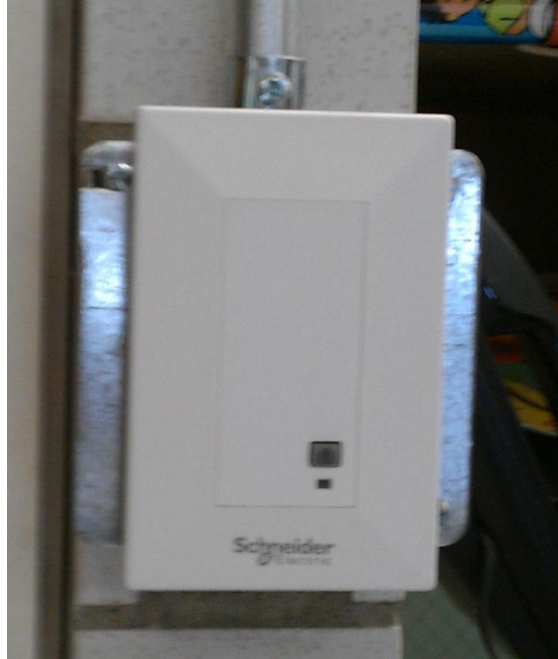
Newer DDC Wall Sensor

- g. Controls: It was reported the DDC system was installed only a few years ago and is in good condition. However it was observed during our site visit (which occurred during a school vacation week) the boilers ran almost continuously while all fan functions ceased and valves defaulted to full open position – this created a hot indoor environment during an unoccupied time period. Schedule programming errors should be further investigated.

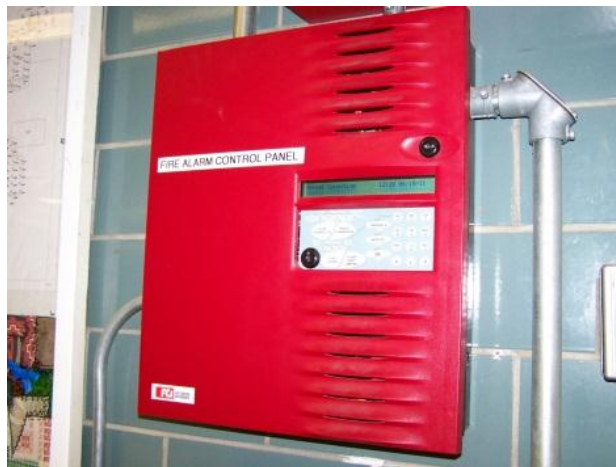
2. The fire alarm system is an addressable type system manufactured by FCI. This system was upgraded in 2001 and is in good condition. The fire alarm control panel is wall-mounted close to the main entrance and also serves as the annunciator. There is an existing fire alarm masterbox and Knox box located on the outside of the building.

Main Fire Alarm Control Panel

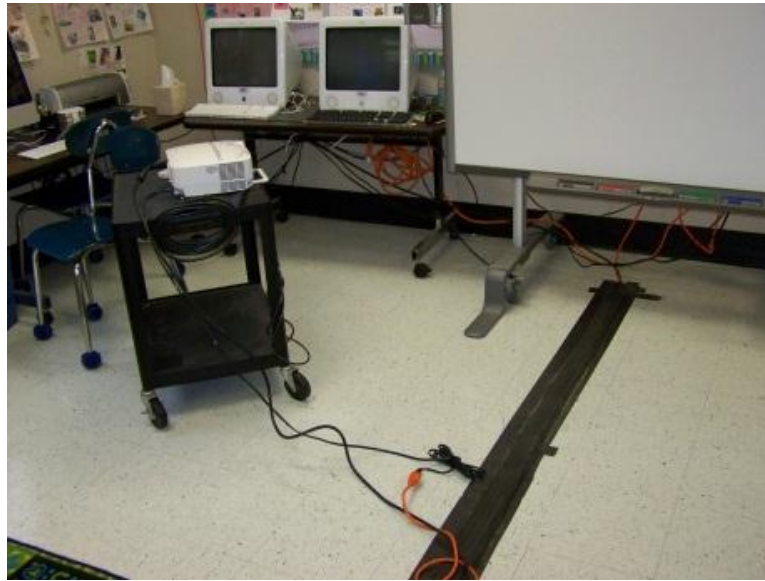
8. Technology distribution is minimal based on modern classrooms. The existing technology in the building appears to be outdated and upgrading the existing is questionable. The main technology rack is located in a closet in the basement that a hatch in the floor that covers a sump pit.
9. Receptacle quantities are not adequate for this application as evidenced by the quantity of extension cords and power strips in the classrooms.

Extension Cords and Strips

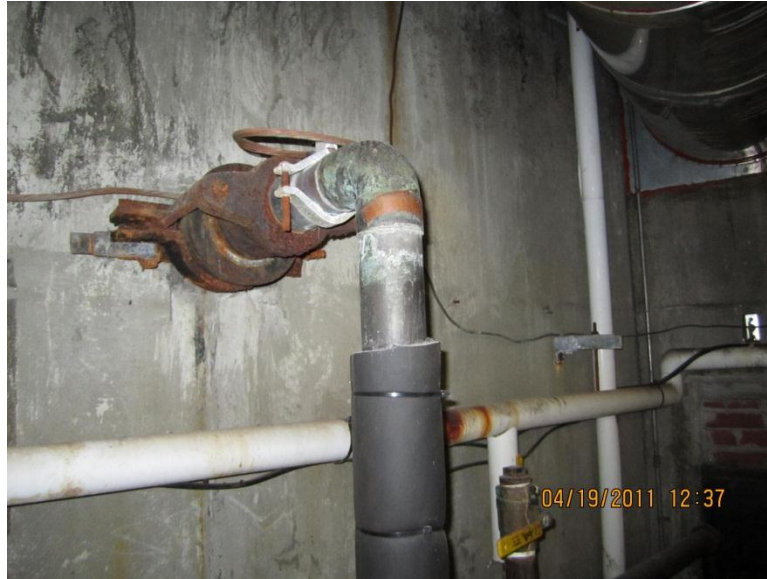
A four inch water service from Glen Gary Road enters the basement boiler room and appears to be original to the building's construction. The service stubs through the foundation wall and appears to reduce down immediately to a three inch pipe.

Water Service Entry

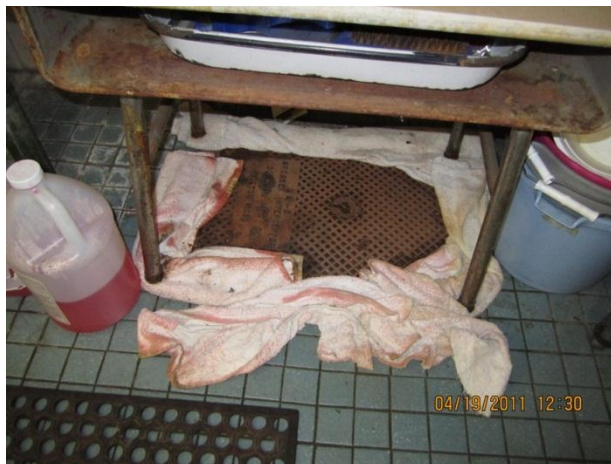
The pot sink in the food preparation kitchen is provided with an in-floor grease interceptor. This interceptor has been covered with rags which is assumed to be due to failure of the cover gasket.

Kitchen Grease Interceptor, Aged and Failing

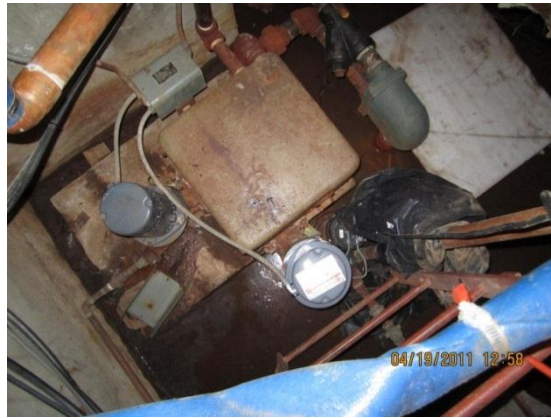
The building foundation includes a pipe trench extending from the boiler room to the north end of the building. The trench contains pipe runs for steam, condensate and water. Apparently, this trench is subject to flooding. During the survey, some standing water was observed in the trench and a small sump pump and hose has been placed below the access hatch into the trench to manage dewatering. The exact cause or source of the water is not evident from this survey, but it is assumed to be ground water entering through the foundation wall. The water may be coming from up the hill on the east side of the property.

Water In Piping Trench
