HILLSIDE SCHOOL

ENVIRONMENTAL EVALUATION

Prefeasibility Environmental Evaluation for Hillside School Property

Project No. 1904

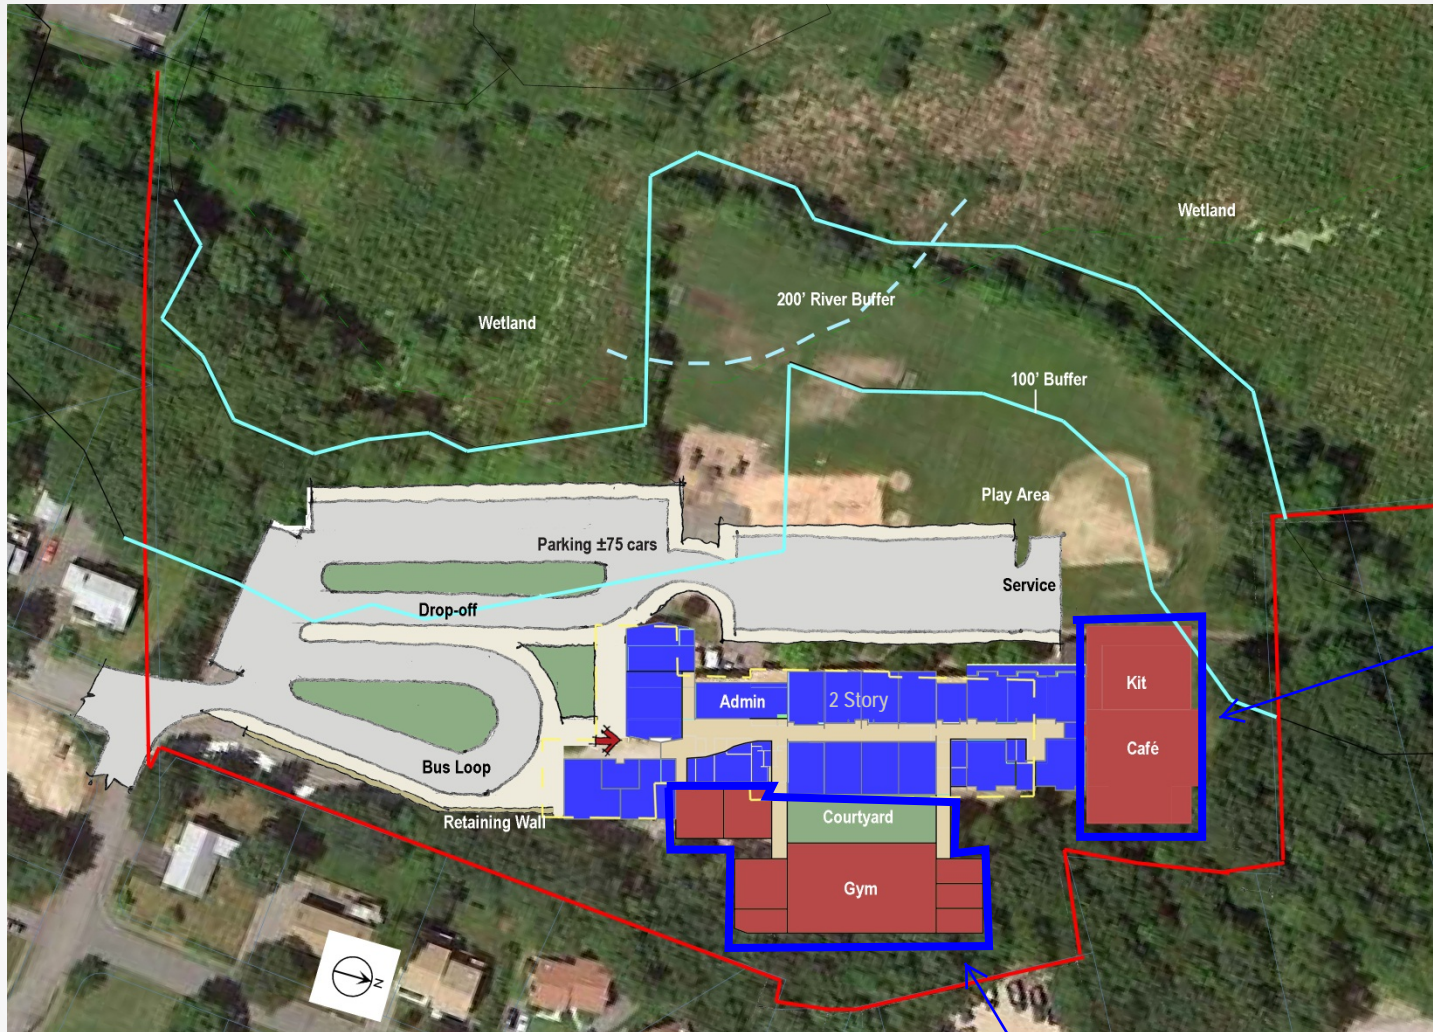
Option 1A.1

10,000 sf +/-

15,100 sf +/-

- Existing/Renovation
- Addition

Each of the proposed redevelopment alternatives involves some expansion to the east into the slope of the hill. Copies of the preliminary architectural drawings are provided in **Appendix B**. Excavation into the slope will encounter contaminated groundwater within a few feet of the surface (pending seasonal fluctuations). Water saturated soil with some

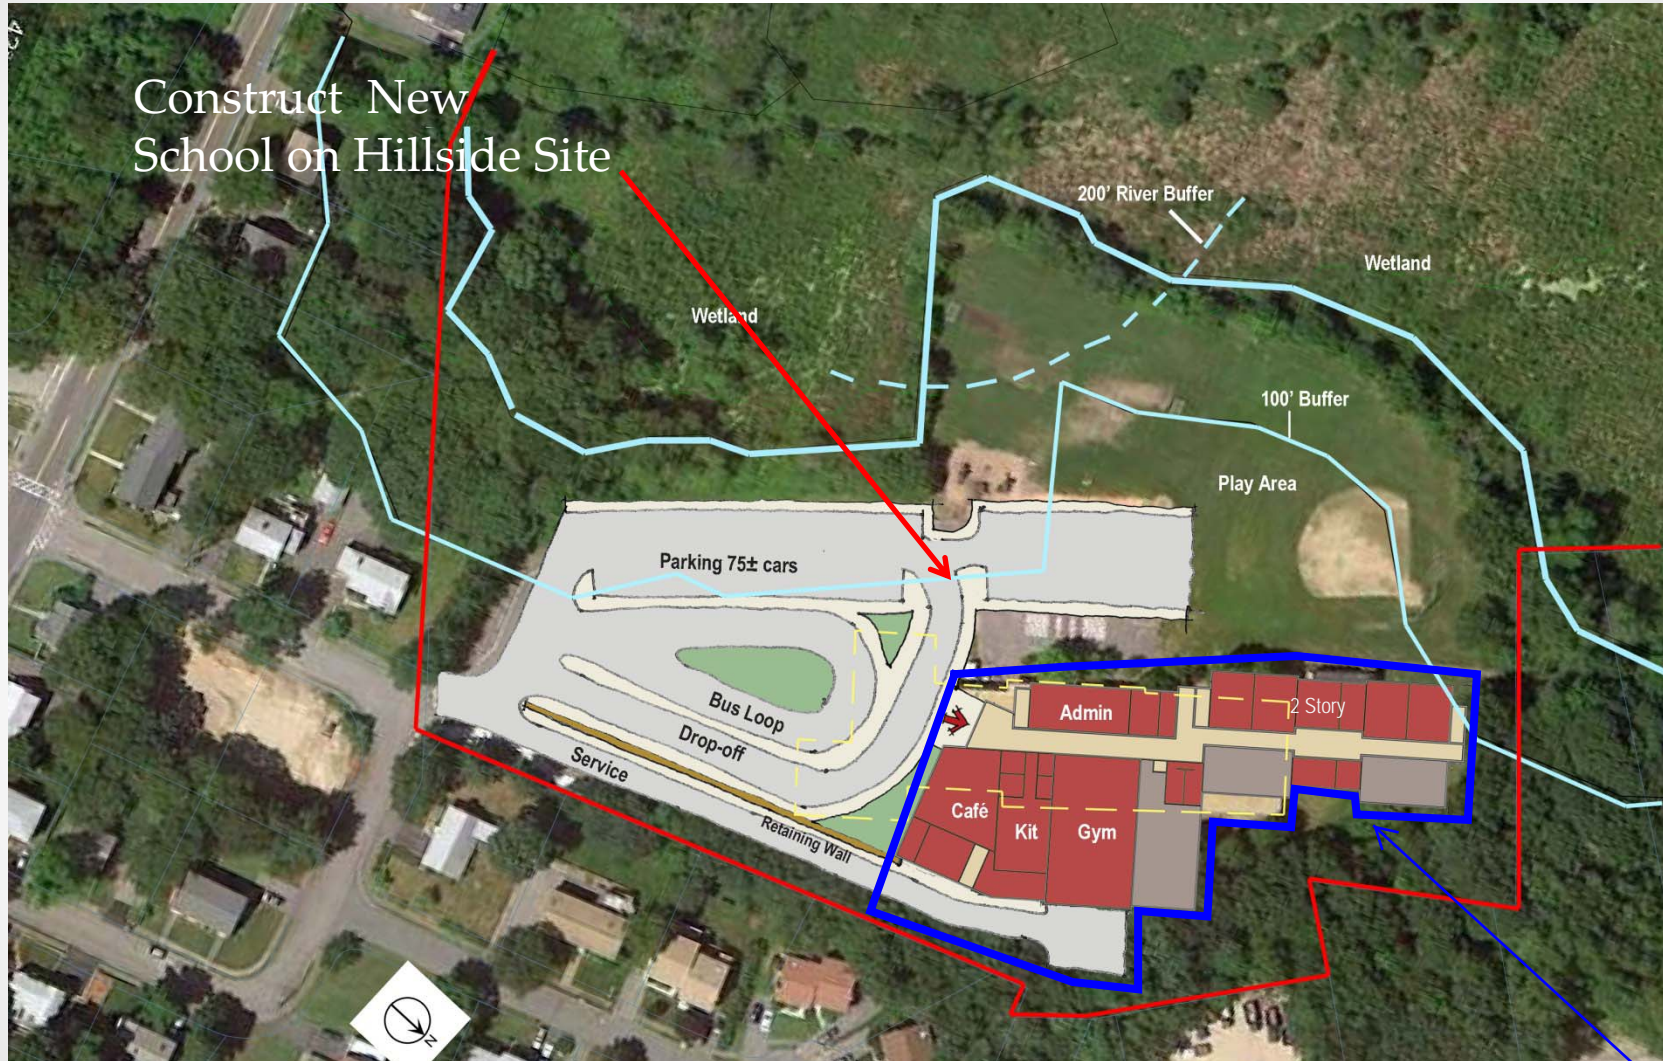
Option 1A.2

Construct New School on Hillside Site

Hillside Site- New School for 487 students

38,000 sf Building Footprint plus 4,000 sf of paved area
