Hillside Elementary School

Civil Assessment

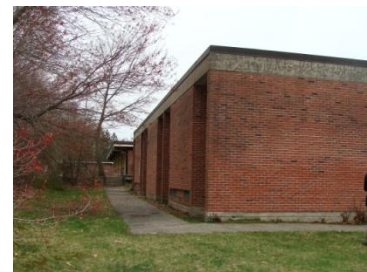
Image 15

The front entry of the school has a handicap accessible ramp in good condition. It is missing edge protection and its dimensions would not meet current code but it is a way for a disabled person to get into the second floor of the school. Railings at the front stairs to the main entrance do not have proper extensions projecting beyond the first stair and would not meet current code. Handicapped access to the first floor is either thru the cafeteria or by way of a wooden ramp at

- Provide accessible path and ramp to library so disabled persons could use that space.
- Provide access to the library.
- Provide edge protection on ramp at main entrance.

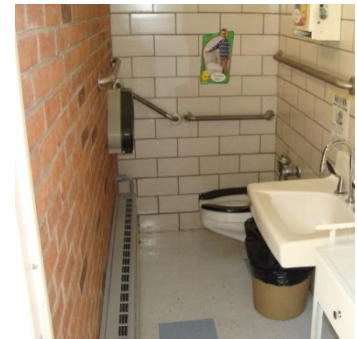
Image 29

The most serious issue is the inability for someone to access all parts of the building. It appears that the only fully accessible bathroom is in the modular building wing on the first floor and there is no way to get from the second floor to the first within the building. Many of the bathrooms, like the one shown in Image 29, are severely undersized. The Library is not accessible from either floor or outside.

- Modify bathrooms on second floor to improve handicapped accessibility.
- See also recommendations listed under Accessible Entrance section of this report.

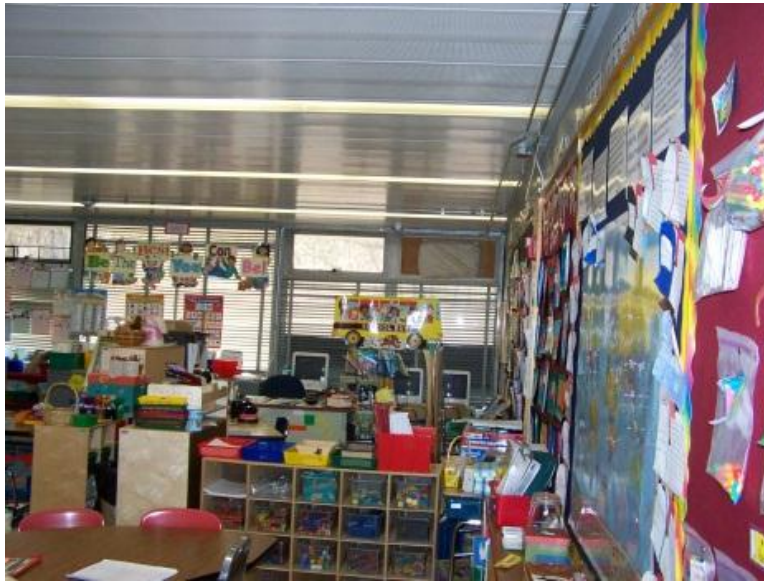
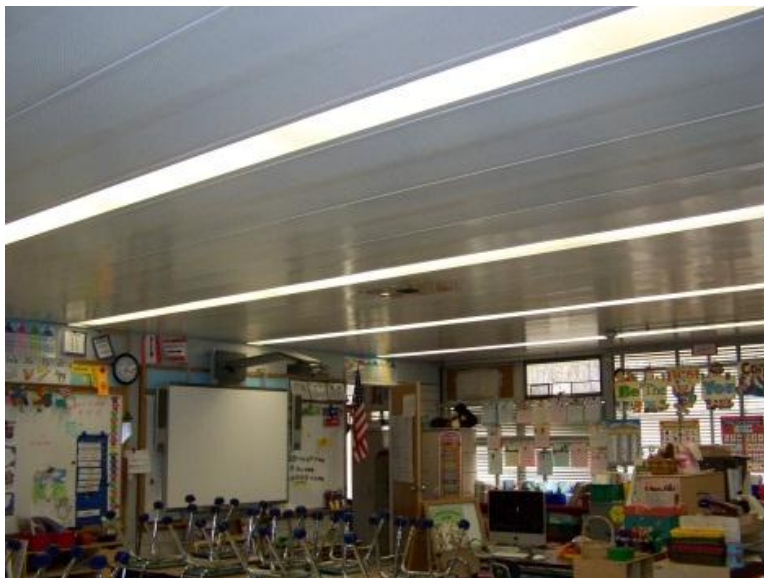
Typical Classroom Fluorescent Fixtures

6. The lighting throughout the classrooms is typically a nominal 1' x 4', recessed flat prismatic lens type arranged in continuous rows, recessed in a metal, perforated ceiling. The fixtures are in good condition and custom fit for this type of ceiling with a 1-lamp cross-section. Lighting in the office area and corridors consists of surface mounted, wrap-around lense type fluorescent fixtures. In the corridors the fixtures are 1-lamp and in the offices they are 2-lamp. Lighting in the gym consists of industrial 'lowbay' type HID, pendant mounted fixtures. The lighting in the modular classrooms mimics the building classrooms regarding appearance. The difference is the ceiling is tile instead of metal.

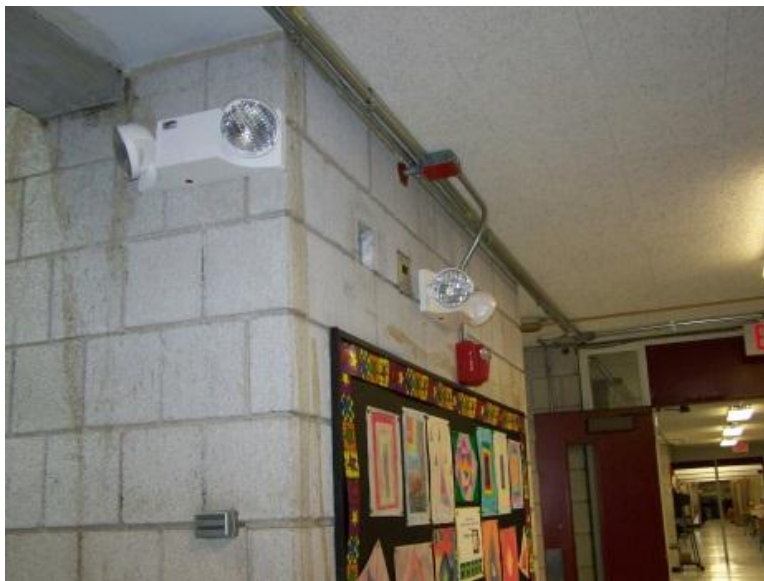
Typical Egress Lighting and Exit Signs

7. Emergency battery wall units and LED exit signs with integral batteries are located throughout.

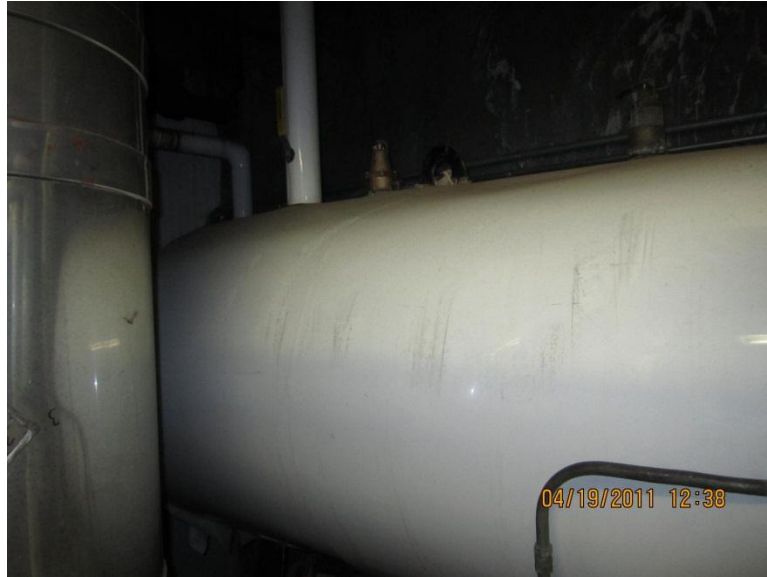
Domestic Hot Water Tank

Domestic hot water is generated with a steam-to-water storage water heater located in the boiler room. It is a horizontal insulated storage tank. Nameplate data on the water heater is not available. It stores water at 120 degrees. The kitchen dishwasher has a local hot water booster.

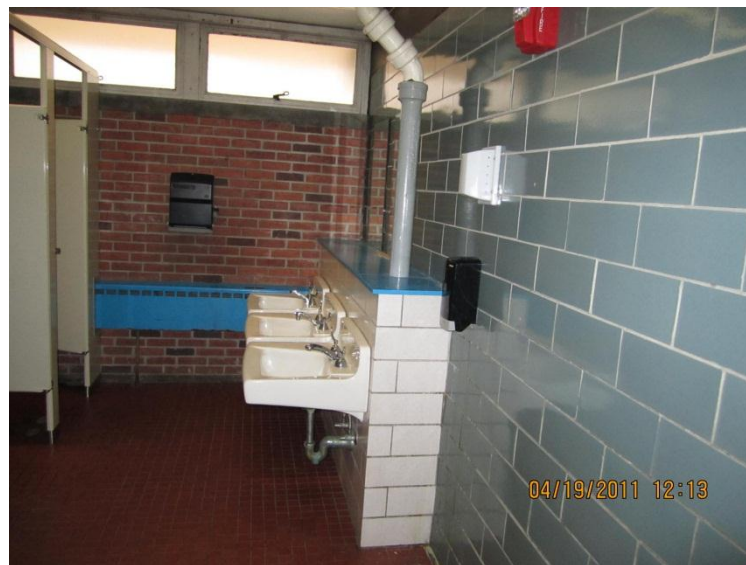
Typical Bathroom Fixtures

The plumbing fixtures in this facility consist mainly of wall mounted water closets and wall hung urinals with flushometer valves. The lavatory sinks are wall mounted. The majority of lavatory faucets are separated hot and cold manual. Janitor sinks appear to be trap-standard design or mop basins and have installed atmospheric vacuum breakers on the faucets. Drinking fountains are a combination of different styles.
